Client, Project and Location USACE New Bedford Resident Office New Bedford Harbor Superfund Site New Bedford, Massachusetts USACE Contract Number DACW33-03-D-0006	Project Note Note No.: 001	Delivery Order/Task Order TO 0005 Project No. 35-BG05-01
Confirmation of <input type="checkbox"/> Project note-P1 <input type="checkbox"/> Client Meeting-P4 <input checked="" type="checkbox"/> Other	Date: July 17, 2007 Issued Recorded: Carl Wilson By	
Subject Collection of Elemental Mercury at the Aerovox Facility	Issued By Mike Anderson

Photo Documentation of Mercury Collection (first round) at Aerovox

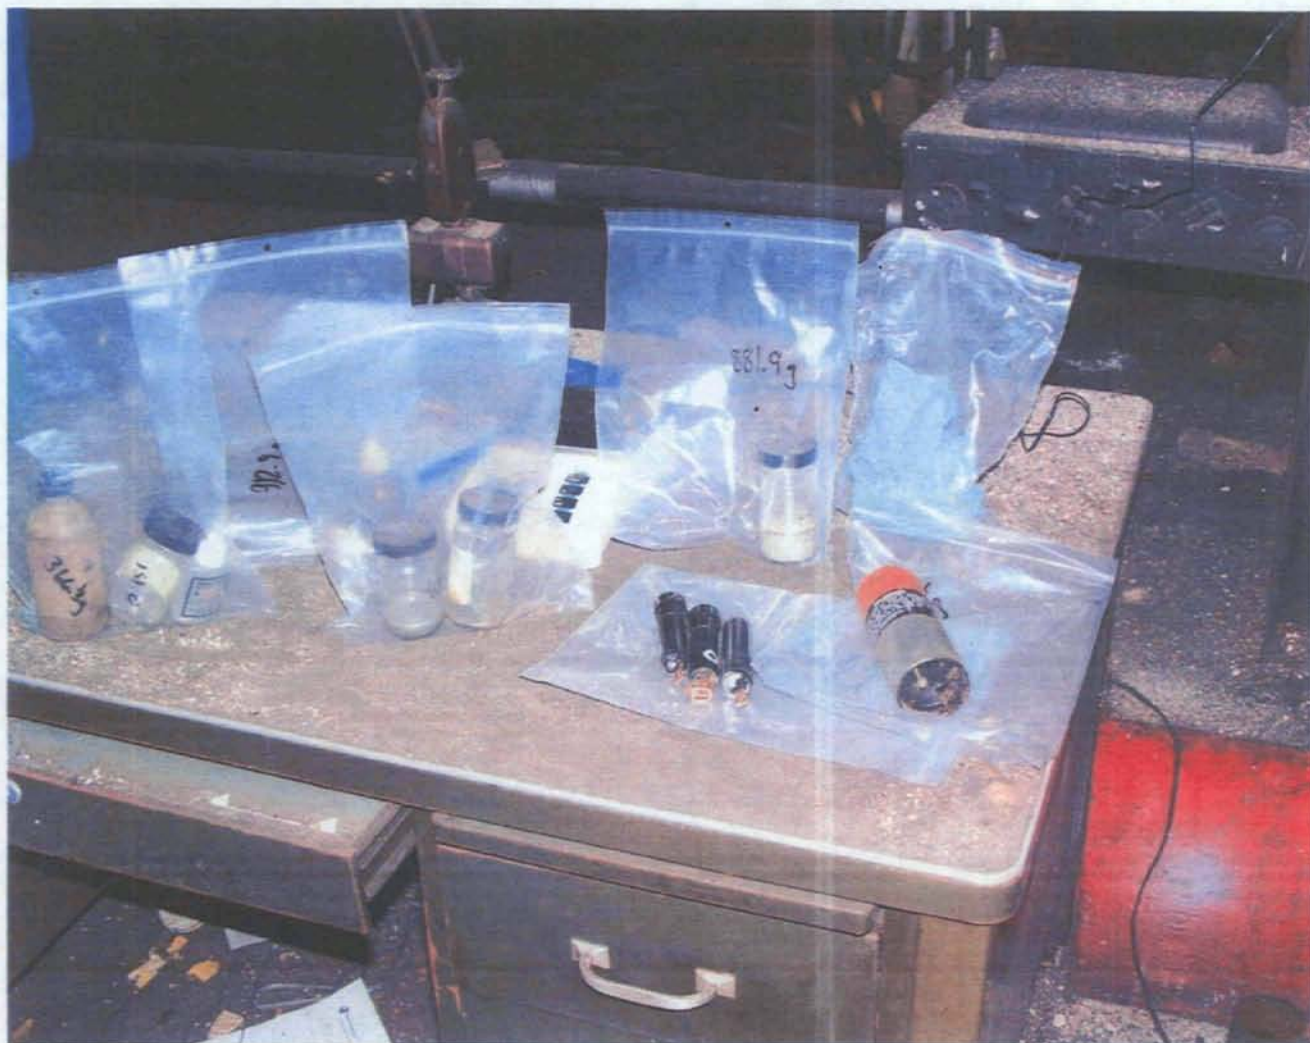
Figure 1 - Mercury Containers and Devices

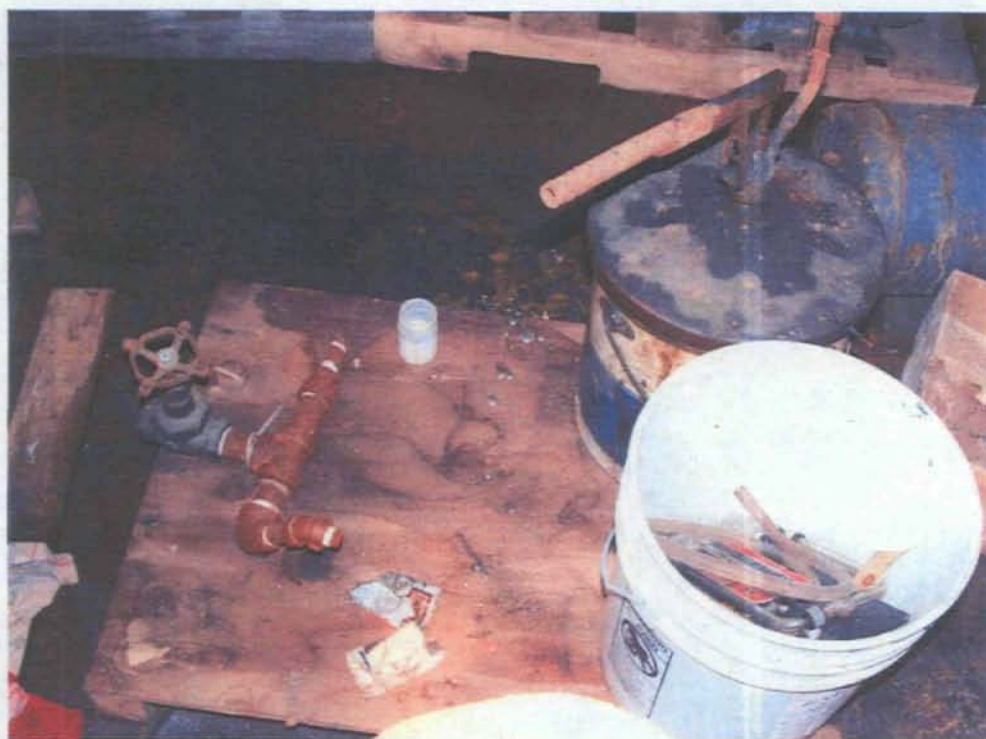
Figure 2 Manometer Spill Before Cleaning

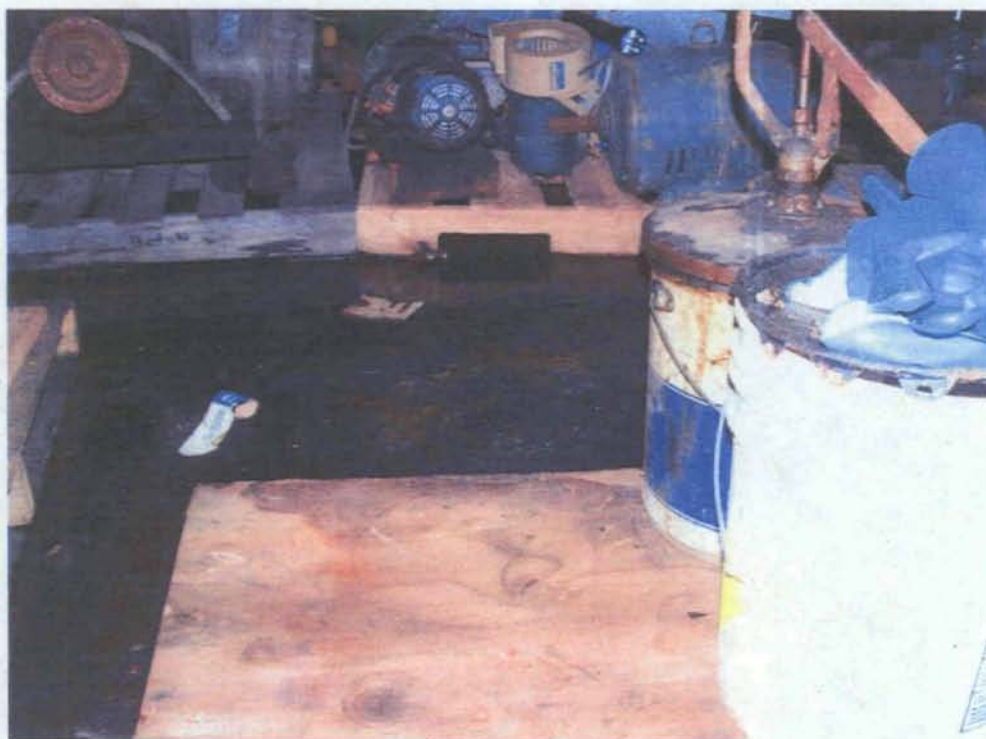
Figure 3 Post Cleanup of Manometer Spill

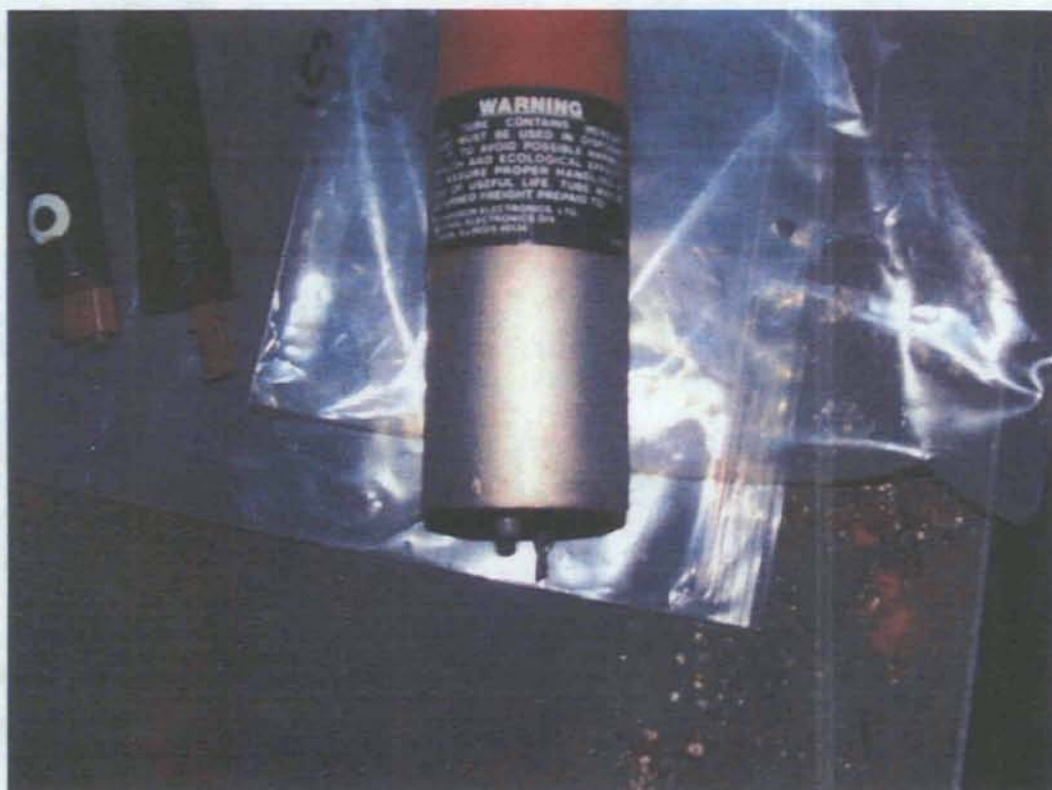
Figure 5 Ignitron Mercury Warning Label
